New York State Department of Transportation

Yellow Flag NB2358W016

BIN: 1065318

Location: Span 246, Stringer S1 at Pier 246

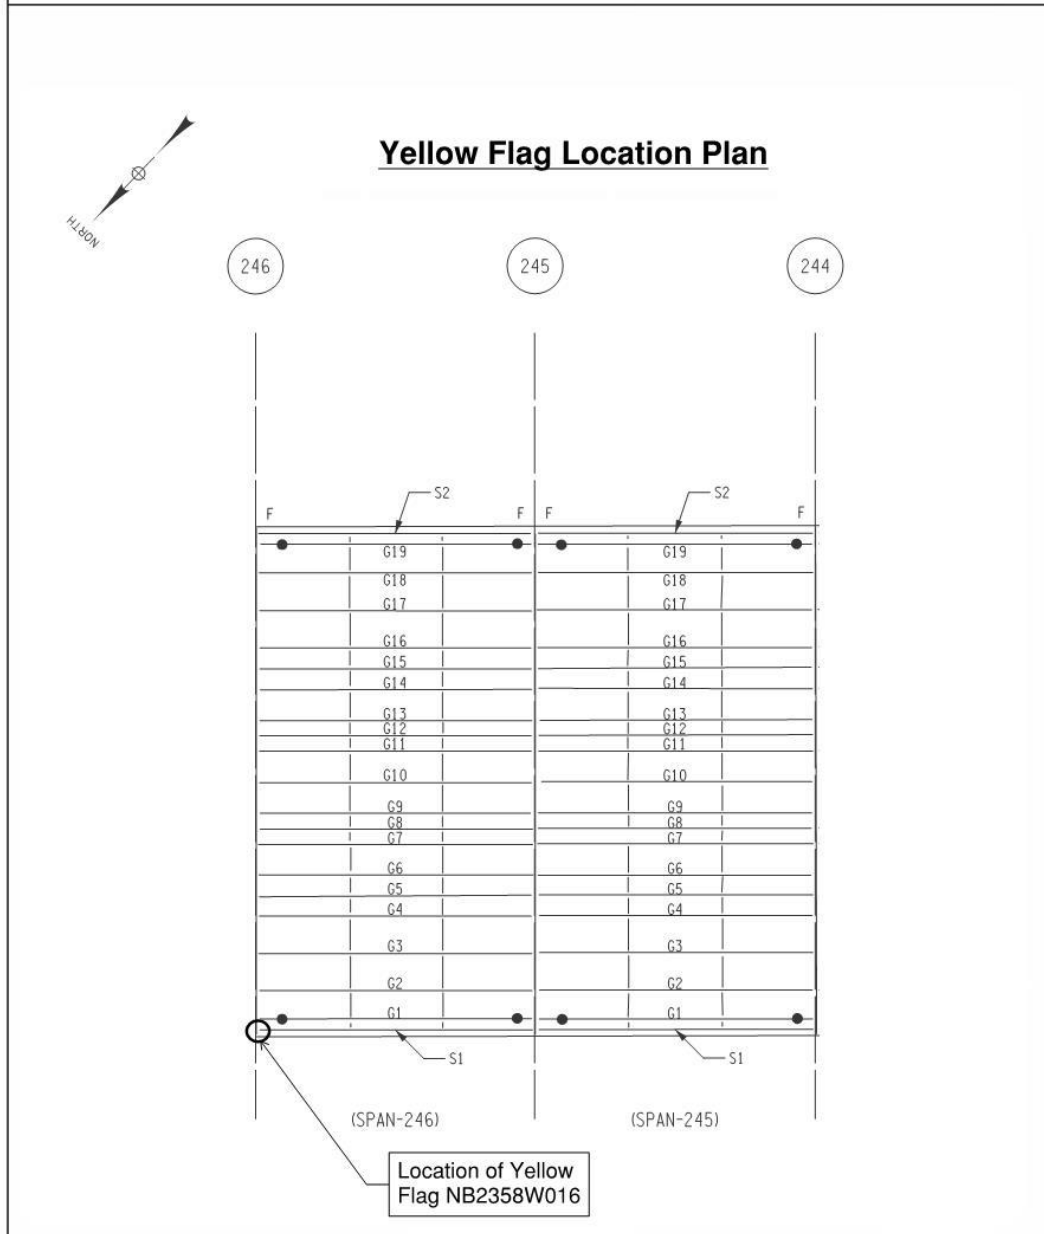
Flag PhotographsPhoto Number: **1**Photo Filename: **23_Flag Location Plan.jpg**Gowanus Expressway
2023 Biennial Inspection - Field SketchBIN: 1065318Team: AA/TSDate: 05/31/2023Span: 246Location: Stringer S1 at Pier 246

**Attachment Description: Flag Location Plan**

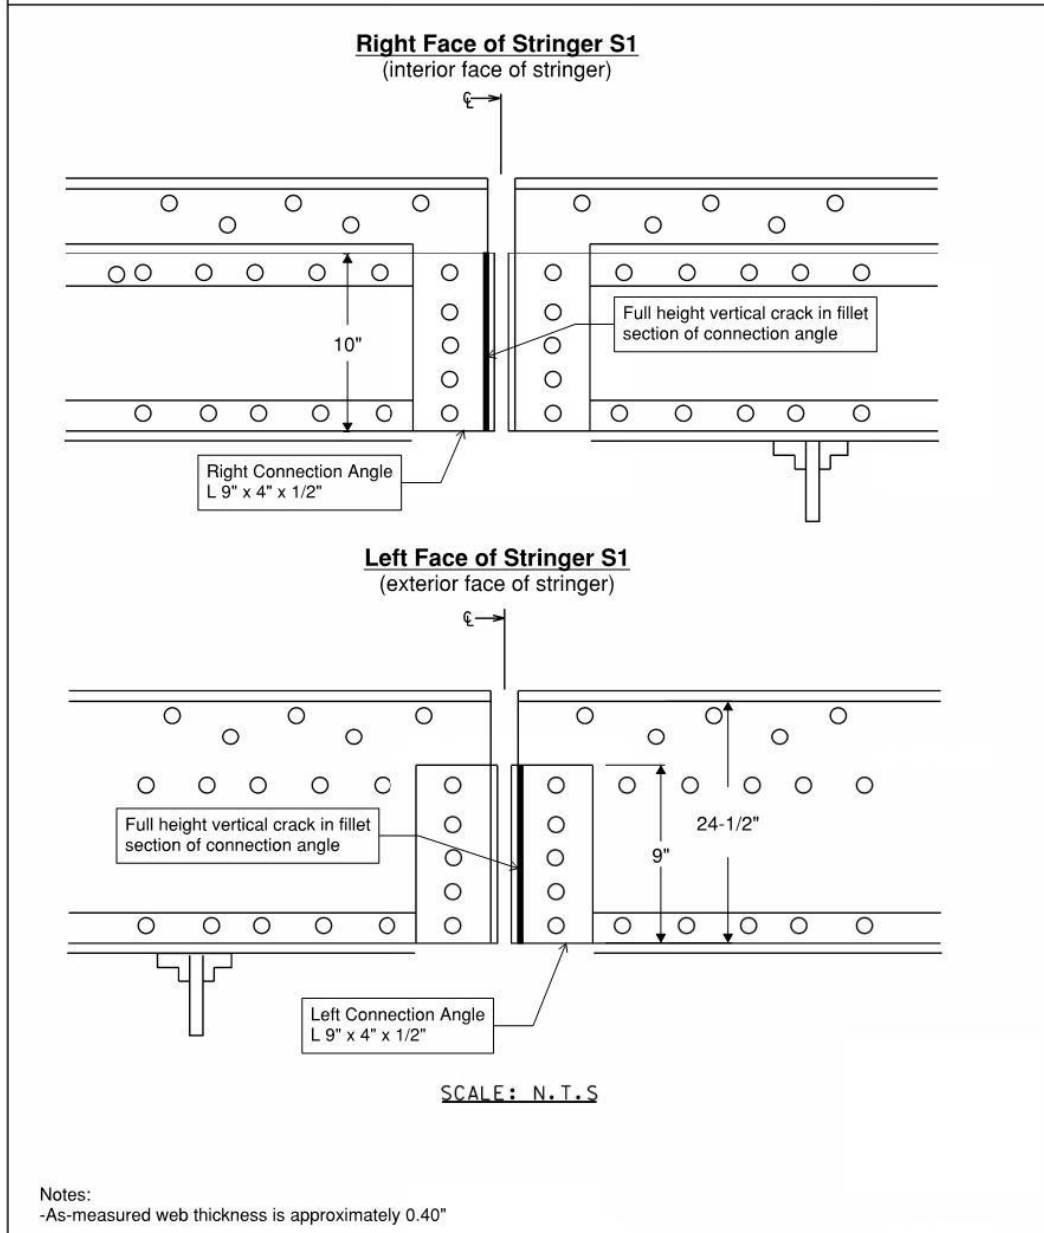
Photo Number: 2

Both connection angles at Stringer S1 in Span 246 at Pier 246 exhibit full height vertical cracks (9" high) in the fillet sections (Photos 4 and 5). The remaining areas of the stringer web and flanges exhibit no significant defects. (refer to Yellow Flag Condition Sketch Photo #2 for more details)

Attachment Description: Flag Condition Sketch

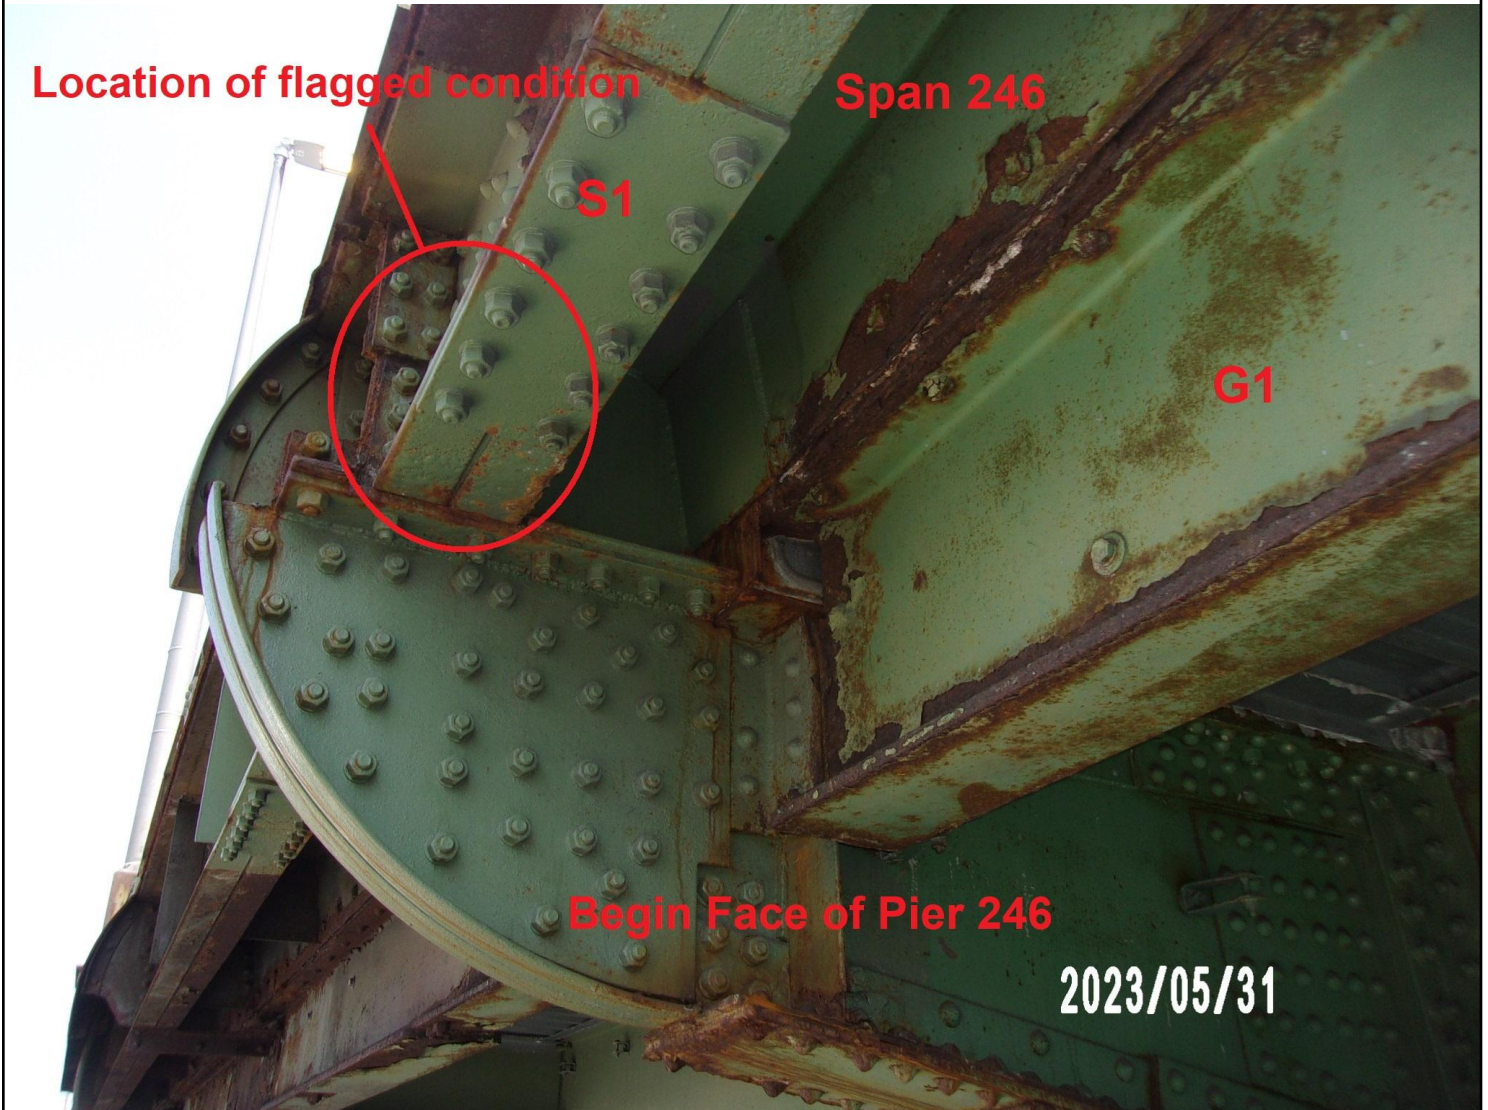
Photo Number: 3

Attachment Description: General view of the flagged condition at Stringer S1 in Span 246 at Pier 246. Looking End.

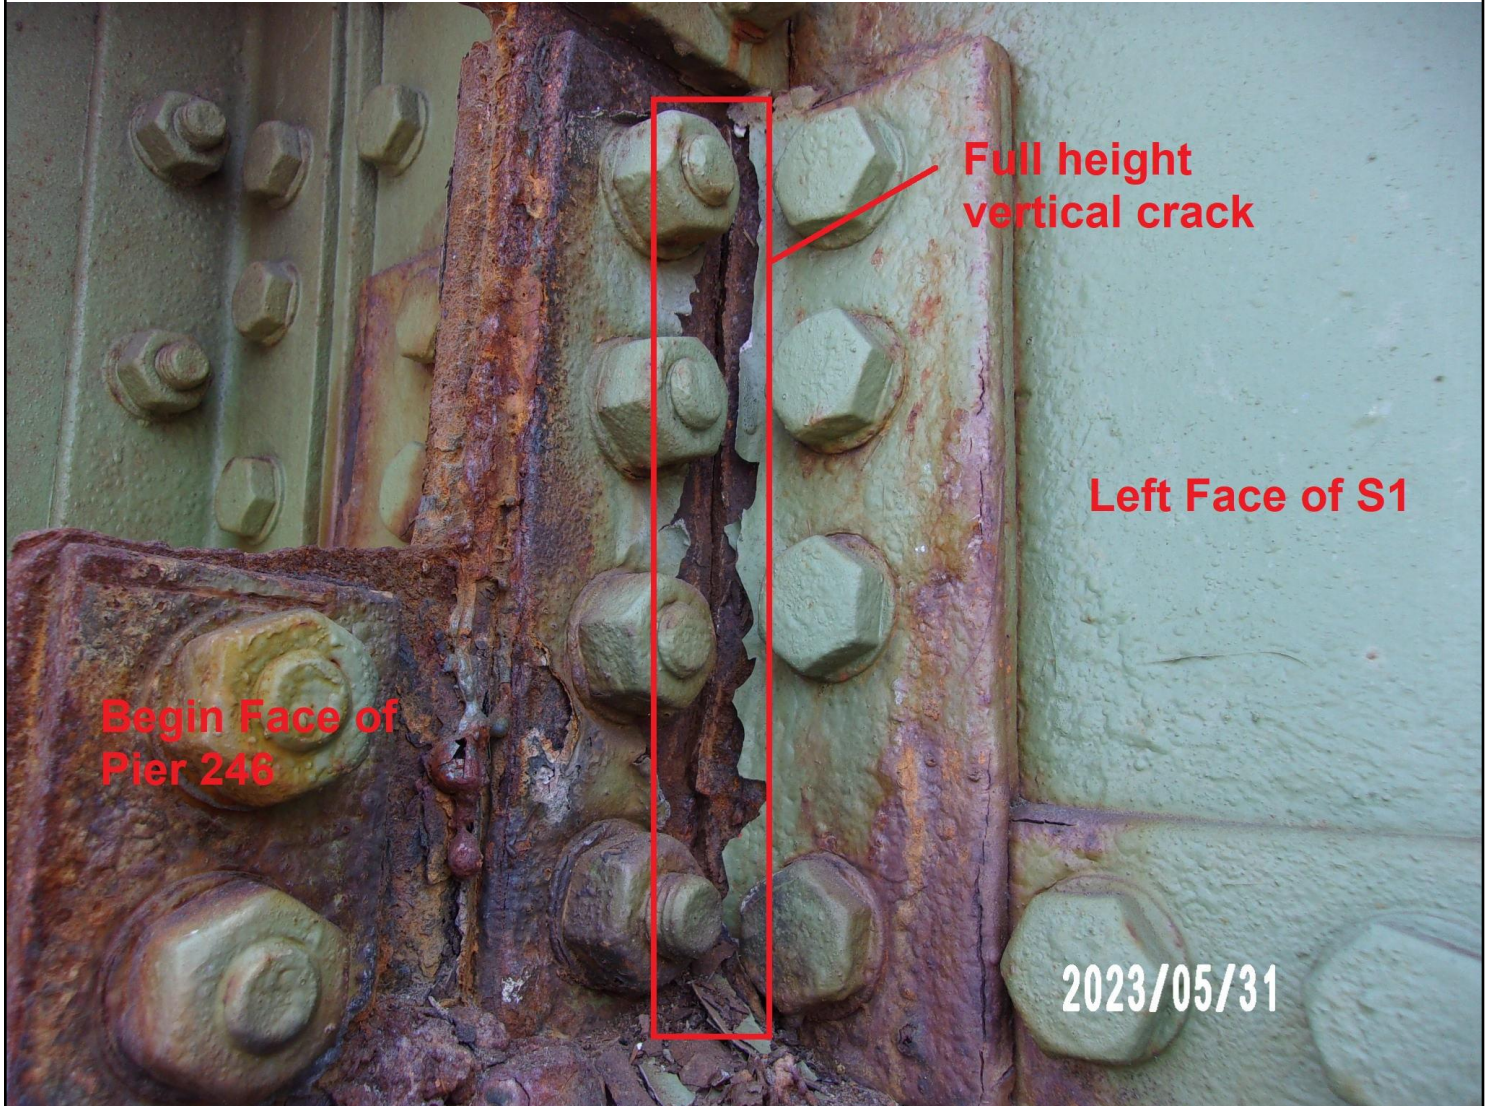
Photo Number: 4

Attachment Description: The left face of Stringer S1 in Span 246 at Pier 246. The left connection angle exhibits full height vertical crack in the fillet section. Looking Right.

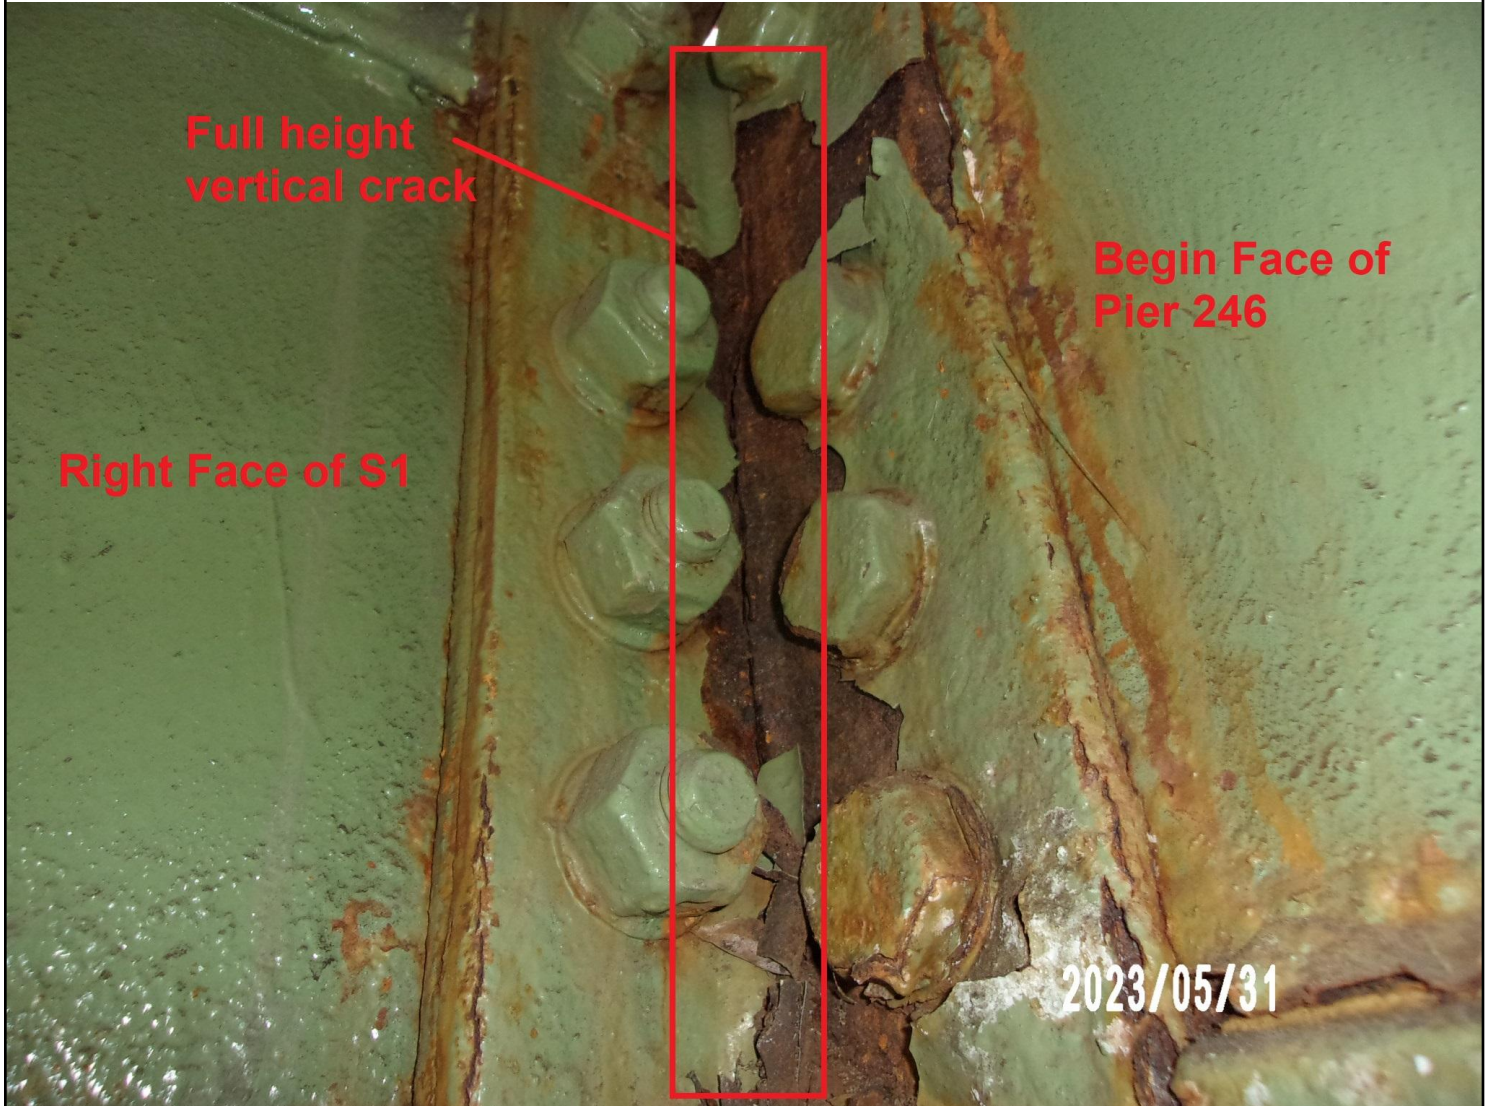
Photo Number: 5

Attachment Description: The right face of Stringer S1 in Span 246 at Pier 246. The right connection angle exhibits full height vertical crack in the fillet section. Looking Left.
